Bank Erosion along the Rajang River in Malaysia

Kazuhiro YUHORA*, Ryoji SODA** and Satoru WATABE***

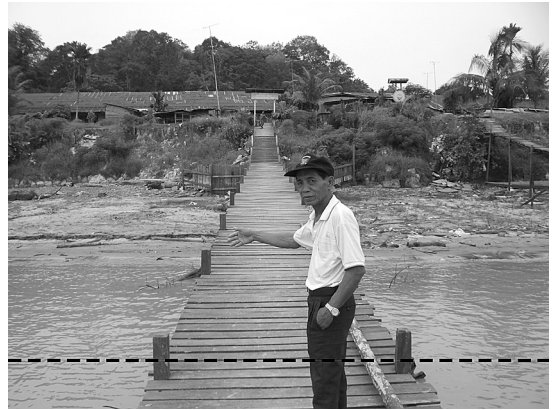
Photo 5. An Iban village chief pointing the past riverbank.

Almost all of the old residents state that the Rajang is gradually widening in the last few decades. In Photo 5, a chief of an Iban village near the Dap Town is showing that the riverbank of thirty years ago was around the broken line, more than 50 meters anterior from the existing bank. He also says “when I was young we could easily swim across the river, but nowadays it is impossible because the river has been widen and the water velocity has become faster.” This kind of statement was heard

throughout the middle Rajang. According to the interview with local residents, the riverbanks have been eroded since the 1970s. The length of eroded land is estimated 20–50 meters, that is, an average of 50–150 cm of land is lost every year.
